International Journal of Innovative Research in Advanced Engineering (IJIRAE) ISSN: 2349-2163
Issue 02, Volume 5 (February 2018) www.ijirae.com

EFFECTIVENESS OF THE SHIELDING MECHANISM IN ROOMS HOUSING X-RAY DIAGNOSTIC EQUIPMENTS (A CASE STUDY OF MULAGO HOSPITAL, UGANDA)

Festo Kiragga
Faculty of science, Department of Physics,
Gulu University, Uganda
jireh4festo@gmail.com
Akisophel Kisolo
Department of Physics, School of Physical Sciences,
College of Natural Sciences, Makerere University, Uganda
akisolo@cns.mak.ac.ug
Rebecca Nakatudde
Department of Radiology, School of Medicine,
College of Health Sciences, Makerere University, Uganda
nakatudde777@yahoo.co.uk

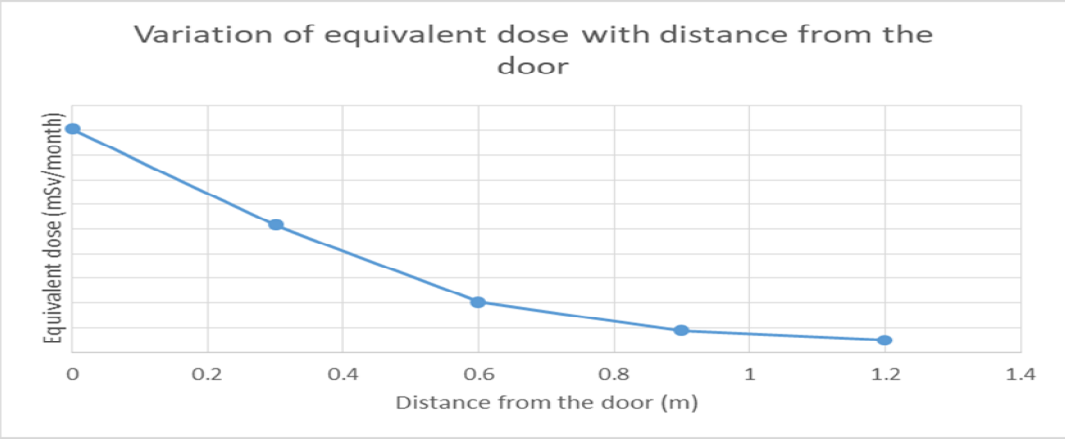
Radiation leakage through the door of UCI at different distances from the door at the same maximum exposure factors. The maximum exposure was 105 KV, 3 mAs.

Distance from the door (m)	Equivalent dose (mSv)
0.0	18.1
0.3	10.3
0.6	4.05
0.9	1.80
1.2	1.01

The figures below show the variation of attenuated radiation with distance from the doors. The graphs indicates that closer to the doors, the Equivalent doses registered are very high. For similar exposure factors, the quantity of radiation is inversely proportional to the square of the distance from the reference point (door), that is, it follows the inverse square law. For exposures near the door, the intensity of the radiation beam is high but decreases with distance as the inverse of the square of the distance from the source. The dose rate value of 18.1 mSv/month implies that the door needs some lead lining to reduce the equivalent dose rate to an acceptable value.

Figure 1. Variation of Equivalent dose with distance from the entrance at the UCI, Mulago
